NIST NCSTAR 1

Final Report on the **Collapse of the World Trade Center Towers**

**National Institute of
Standards and Technology**

September 2005

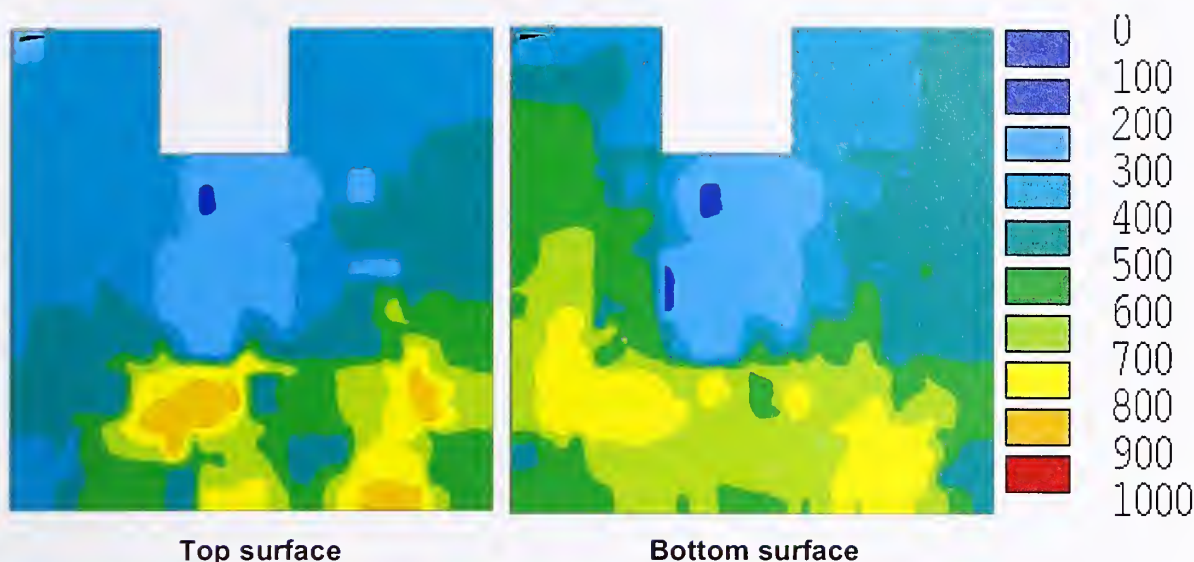
Figure 2-11. Temperature contours (°C) on the top and bottom faces of the concrete slab (96th floor, WTC 1) at 100 min after impact. A portion of the concrete slab on the north face (top) was damaged by the impact of the aircraft.

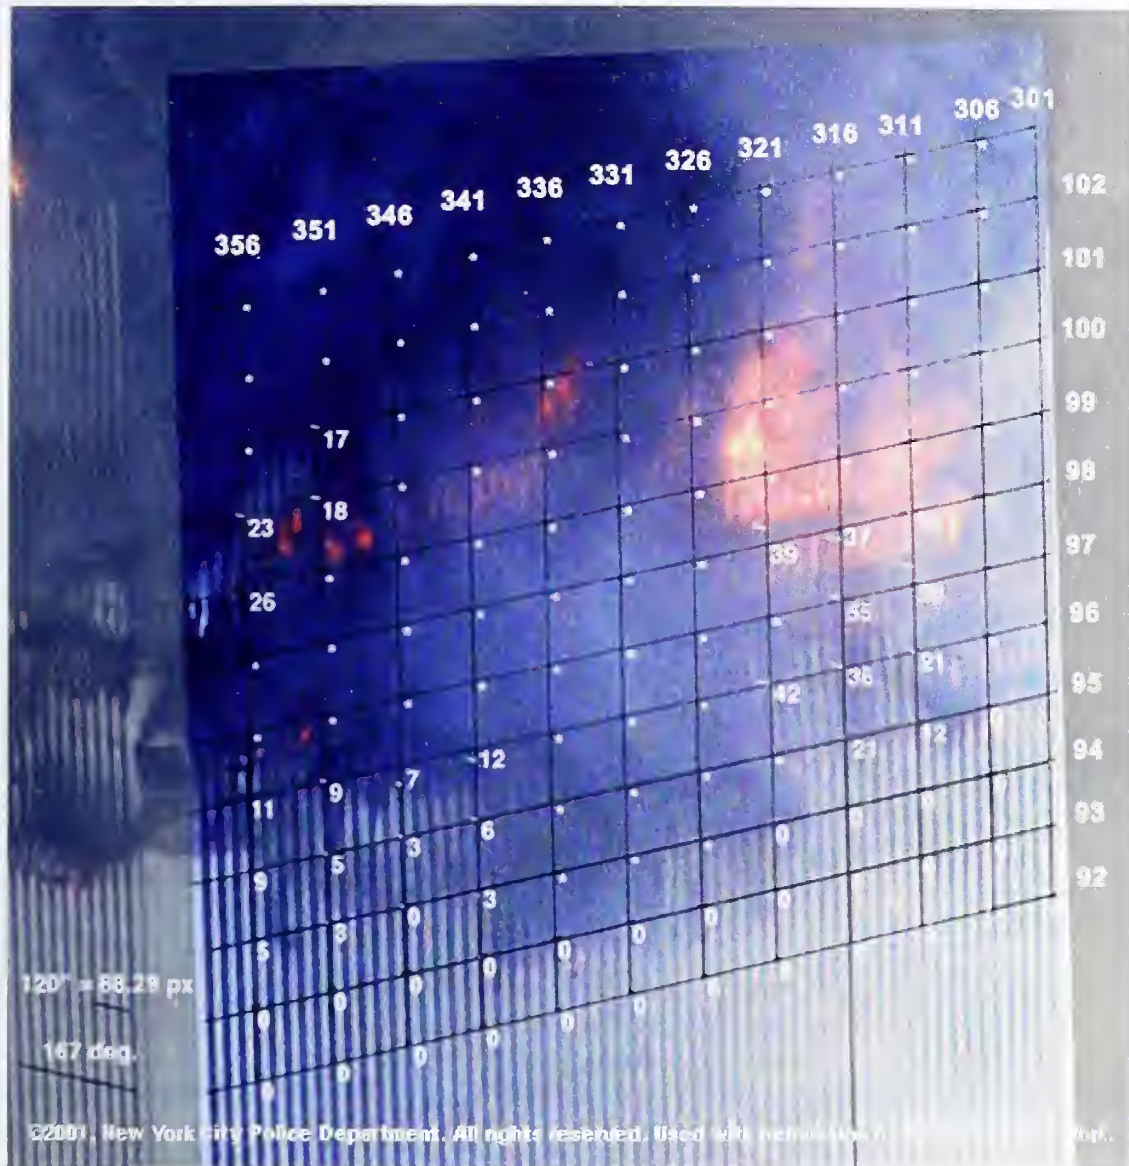
The sagging of the floors had increased. Although the floors on the north side of the tower had sagged first, they contracted due to cooling when the fires moved toward the south. Now, the south side floors had sagged to the point where the south perimeter columns bowed inward (Figure 2–12). By 10:23 a.m., the south exterior wall had bowed inward as much as 55 in.

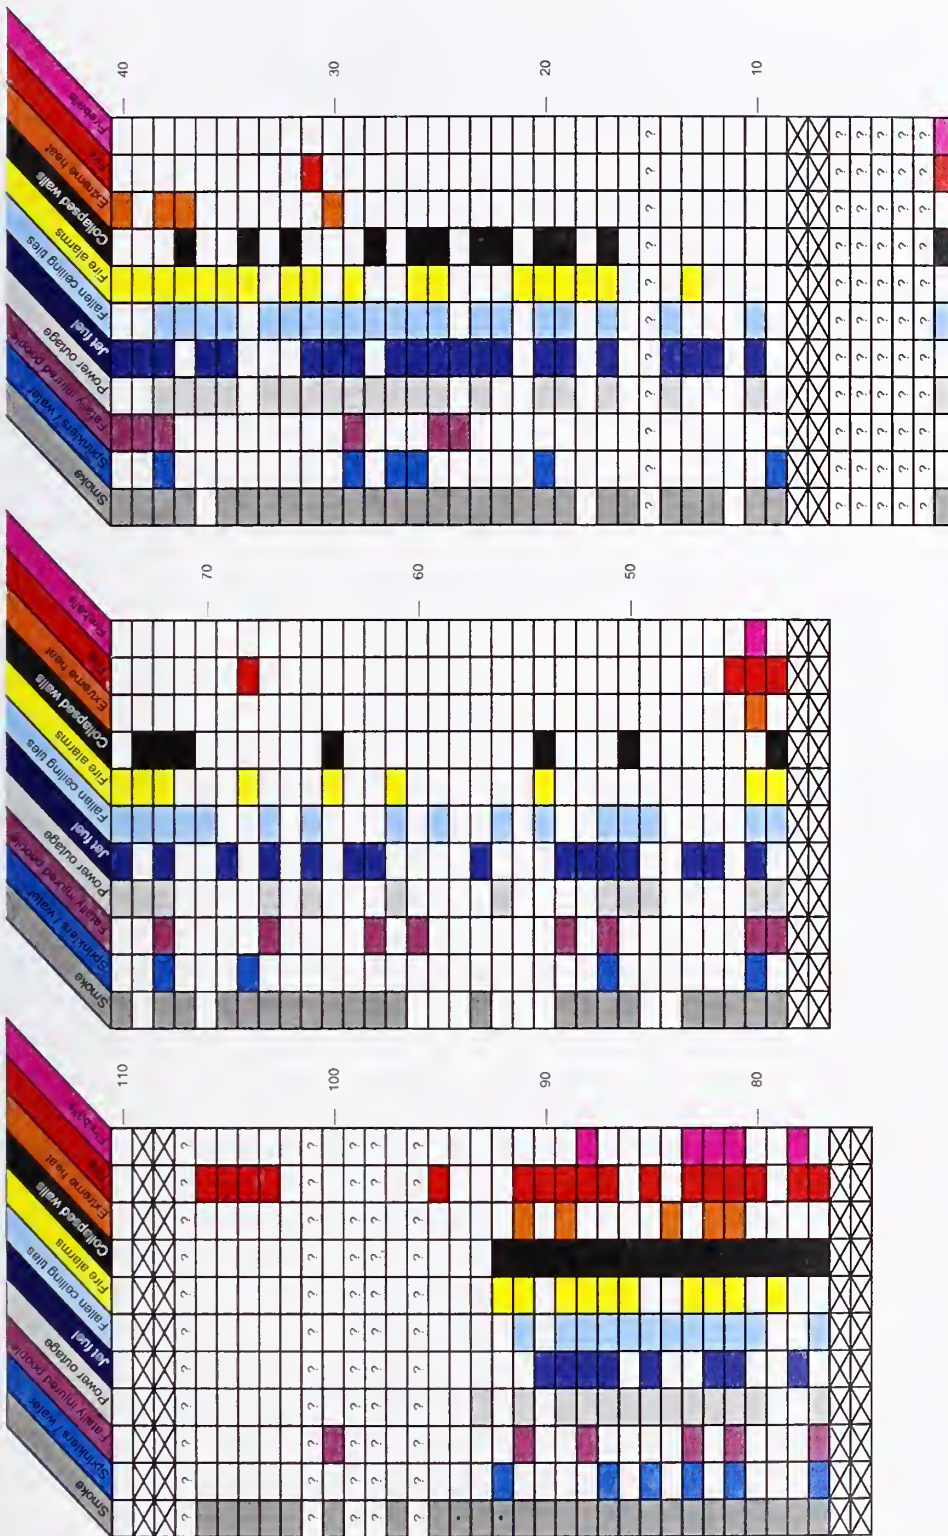
Figure 7-3. Observations of building damage after initial awareness but before beginning evacuation in WTC 1.

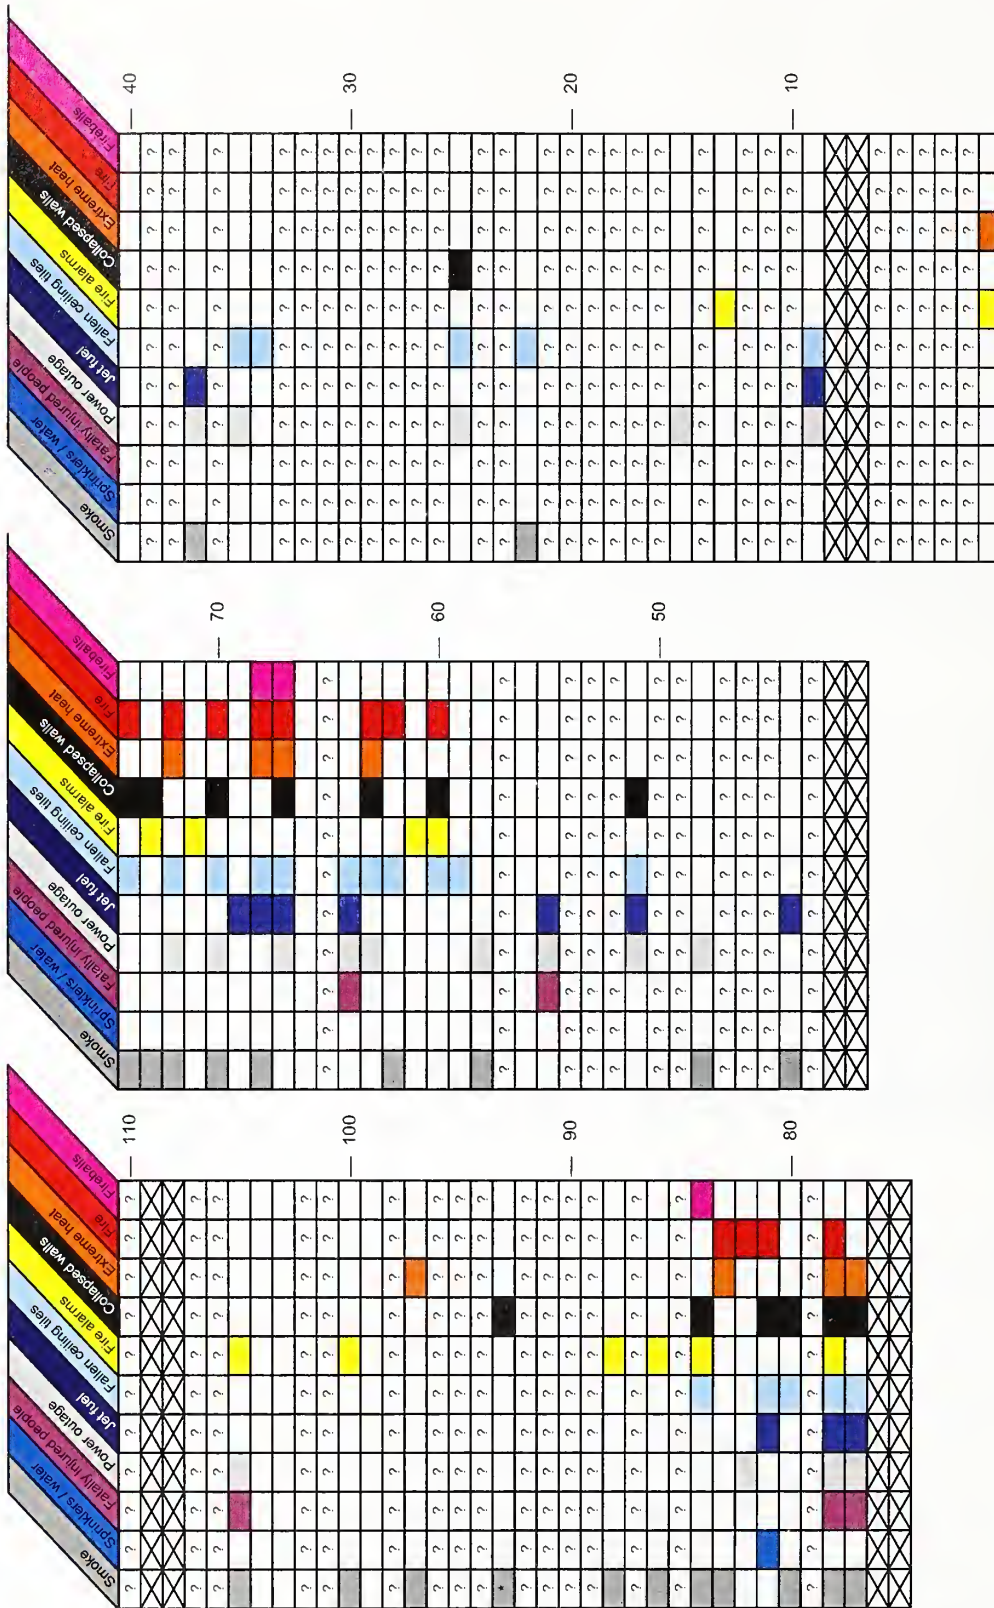
Figure 7-4. Observations of building damage from tenant spaces in WTC 2.
